Manhole Inspection Summary

Manhole # S25Q__001MH

Location Address: **1411 BUSH ST.**

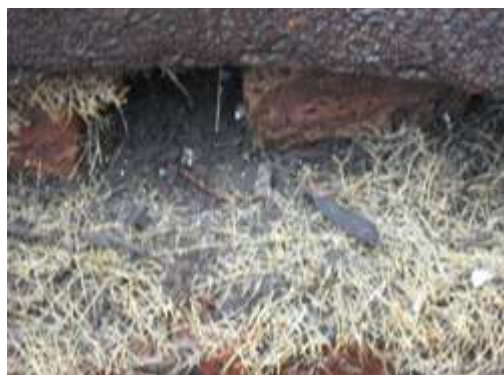
Defect 4

MISSING MORTAR AND BRICKS WITH EVIDENCE OF INFILTRATION, ROOT INTRUSION

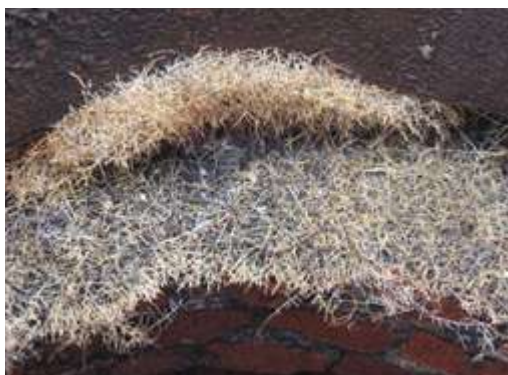
Defect 3

Condition: ☐ Sound ☐ Cracked ☒ **Root Intrusion** ☐ Loose Brick ☐ Deteriorated

Infiltration: ☐ None ☐ Joint ☐ Cracks ☒ **Mortar** ☐ Roots ☐ Wall

ROOT INTRUSION WITH EVIDENCE OF INFILTRATION AT CHIMNEY

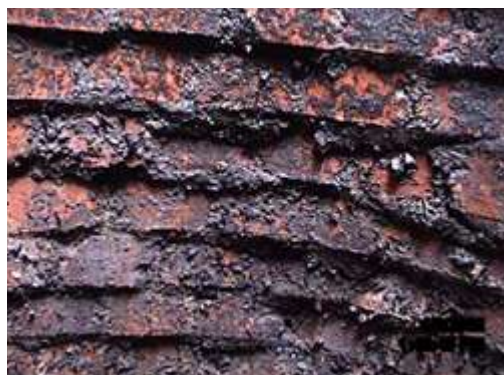
Defect 2

Infiltration: ☐ None ☐ Joint ☐ Cracks ☐ Mortar ☐ Roots ☒ **Wall**

EVIDENCE OF BARREL INFILTRATION

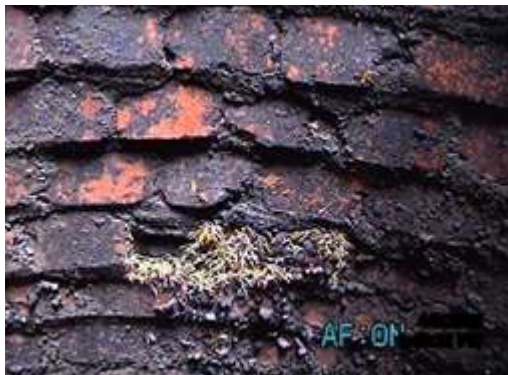
Defect 1

Condition: ☐ Sound ☐ Cracked ☒ **Root Intrusion** ☐ Loose Brick ☐ Deteriorated

ROOT INTRUSION AT BARREL

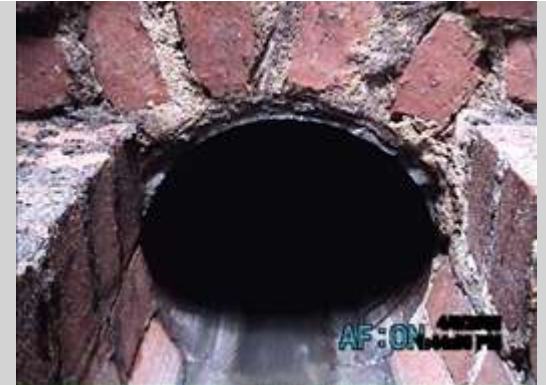
12 O'Clock Outflow

10 in. Circular Gravity Sewer
Pipe Out @ 12 O'Clock

Pipe Height: **10.8** (in.) Rod and Bar (Angled)
Pipe Material: **Clay** ☐ Pipe Lined
Invert Depth: **7.80** (ft.) Flow Characteristics: **Slow**
Deposits: ☒ None ☐ Mud ☐ Sludge ☐ Debris ☐ Grease
Silt Depth: **0** (in.) Deposits Extent:
Infiltration: **None** Pipe Seal Cond: **Sound**

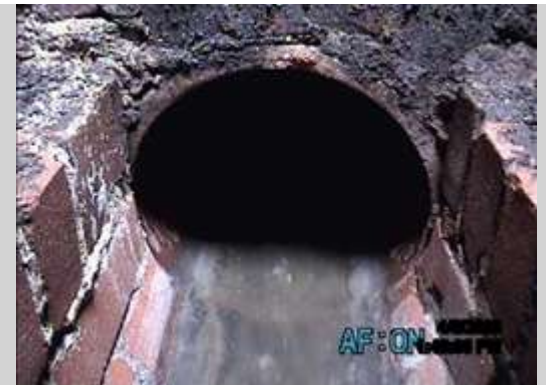
6 O'Clock Inflow

10 in. Circular Gravity Sewer
Pipe In @ 6 O'Clock

Pipe Height: **10.8** (in.) Rod and Bar (Angled)
Pipe Material: **Clay** ☐ Pipe Lined
Invert Depth: **7.85** (ft.) Flow Characteristics: **Slow**
Deposits: ☒ None ☐ Mud ☐ Sludge ☐ Debris ☐ Grease
Silt Depth: **0** (in.) Deposits Extent:
Infiltration: **None** Pipe Seal Cond: **Sound**
